Article

Optical Sensing of the Fatigue Damage State of CFRP under Realistic Aeronautical Load Sequences

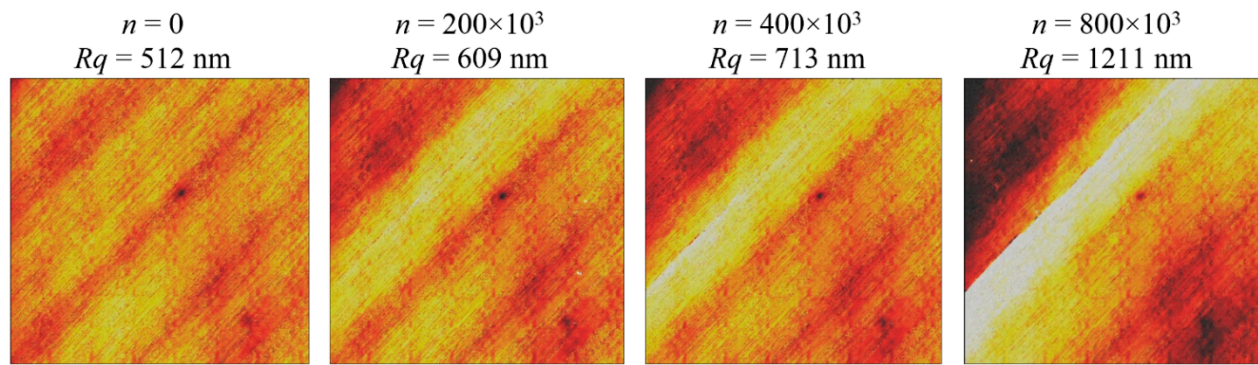
Figure 1. Evolution of the surface topography due to fatigue damage of a CFRP specimen.

Previous studies [17,18] have shown that the magnitude of the surface roughness increases due to changes in the topography that have been induced by the damage. The changes of the surface start at the beginning of the life of the structure with matrix micro-cracks. With increasing cycles, the cracks become bigger and produce local delaminations. At the end of the life the local delaminations become deeper. Figure 1 shows the evolution of the surface topography for a particular and representative case of a CFRP specimen after different numbers of fatigue cycles. From previous studies we have established that the roughness parameter which has a better correlation with the accumulated damage of the material is the root mean square (standard deviation), commonly known as Rq , which is determined by the next equation, where z_i is the value of the height of the measured point i respect to the mean plane of the surface, and P is the total number of measured points (pixels) per surface [19,20]:

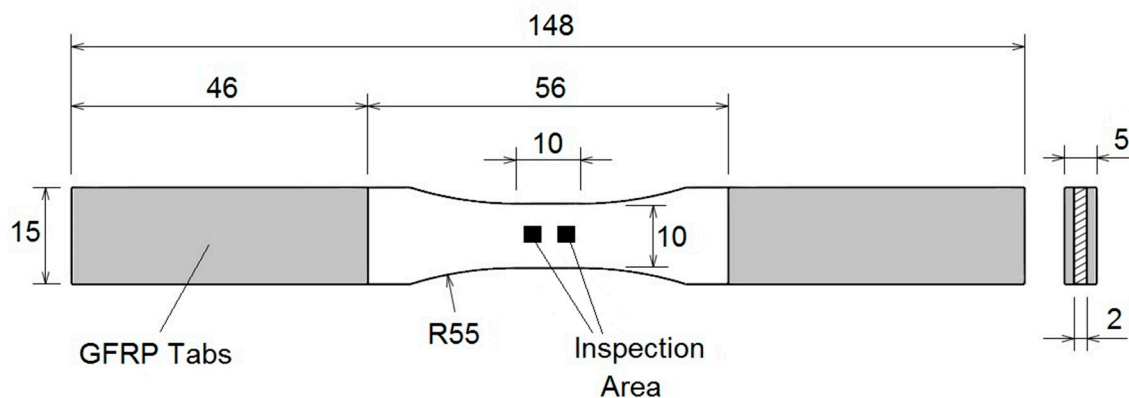
Figure 2. “Dog bone” geometry of the CFRP coupons used for tensile variable amplitude tests. Inspection area of one of the faces of the coupon.

Nine coupons with “dog bone” geometry have been manufactured from the panel (see Figure 2). This geometry is selected to guarantee that the damage of the coupon is produced in a controlled zone, (gage zone) which corresponds to a volume of $10 \times 10 \times 2 \text{ mm}^3$. Tabs made of GFRP were bonded on the specimen ends in order to avoid spurious stresses due to the gripping force of the test machine clamps.

Measuring the surface roughness in several points is recommended in order to obtain an adequate statistic of the damage. In the present work, the surface roughness of each coupon was measured in four points in the gage zone, two points in the front face and two points in the back face (see Figure 2). Each test point has an area of $1.55 \times 1.49 \text{ mm}^2$, which has been established in order to evaluate a similar area and scale than the used in laser speckle techniques. The topography of the surface at each area of evaluation is obtained by confocal microscope by measuring the heights of the surface in a discretized area of 4675×4478 pixels, where each pixel has an area of $0.33 \times 0.33 \text{ }\mu\text{m}^2$. To present the results of roughness evolution, the four points of examination have been averaged with the aim to present one value of evolution per coupon.

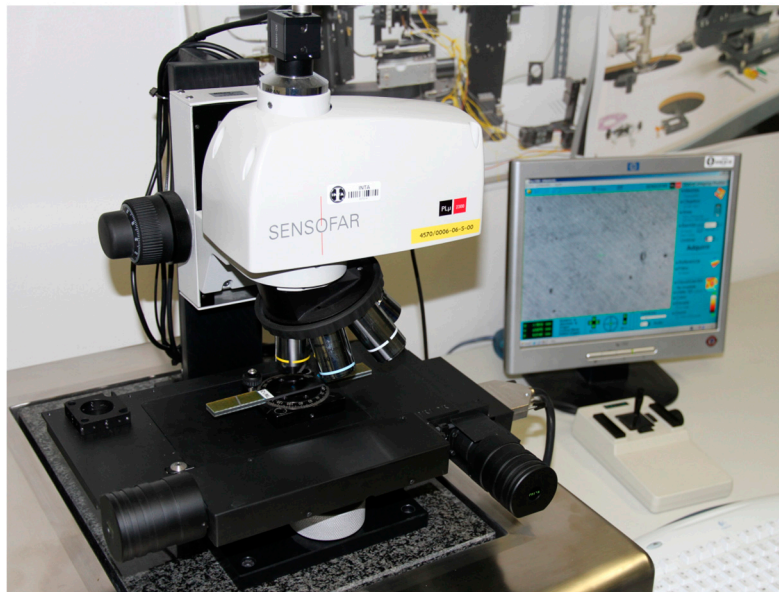
Figure 3. Experimental setup to measure the surface roughness by the confocal microscope.

A hydraulic test machine (MTS 810 from MTS Systems Corporation, Eden Prairie, MN, USA), under load controlled conditions, was used for the fatigue tests. The surface topography was obtained by a confocal microscope (PLμ Confocal Imaging Profiler, from Sensofar, Barcelona, Spain) with an objective zoom of 50× and an axial resolution of 5 nm. The experimental setup to measure the surface roughness of the coupons with the confocal microscope is shown in the Figure 3.

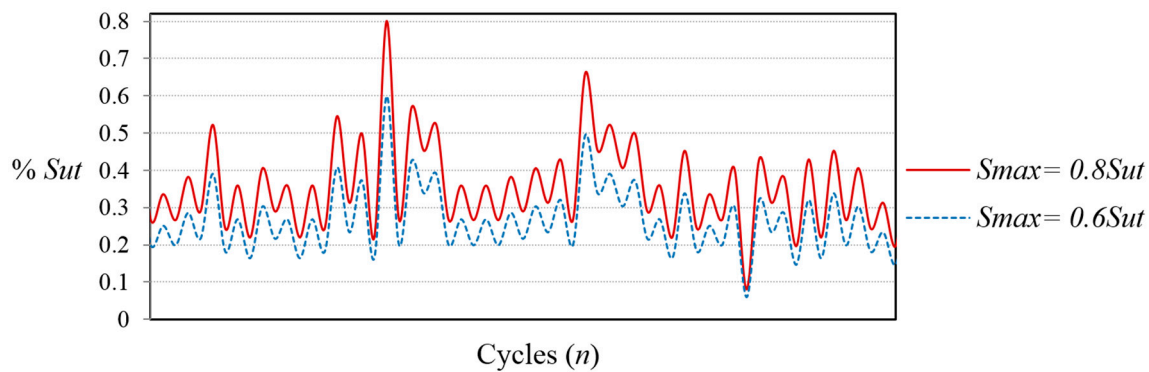
Figure 4. Fragment of the FALSTAFF load sequence with two different magnitudes of maximum peak load.

The FALSTAFF load sequence is a standardized representation of the loads supported by the wing roots of fighter aircrafts during 200 flights (1 year of typical usage), under the combinations of different types of missions and maneuvers [23]. The total number of cycles of the FALSTAFF load sequence is 1.054×10^6 cycles of different magnitude, and has been applied to the coupons in order to evaluate the fatigue damage under VAL.

VALs have been applied at 10 Hz with an $R = 0.1$, where the relation of the maximum peak load of the sequence and the minimum valley of the sequence is 10:1. In order to evaluate load sequences of different severity, FALSTAFF has been scaled to different magnitudes of maximum peak load. Table 1 shows the load sequences applied to the coupons and Figure 4 illustrates a fragment of the load history applied to the coupons with two different magnitudes of maximum peak load. If the coupon did not fail within the load history, the sequence was repeated until failure, with a limit of 10 million of cycles. The fatigue tests have been interrupted periodically before failure in order to perform the measurement of the surface parameters.

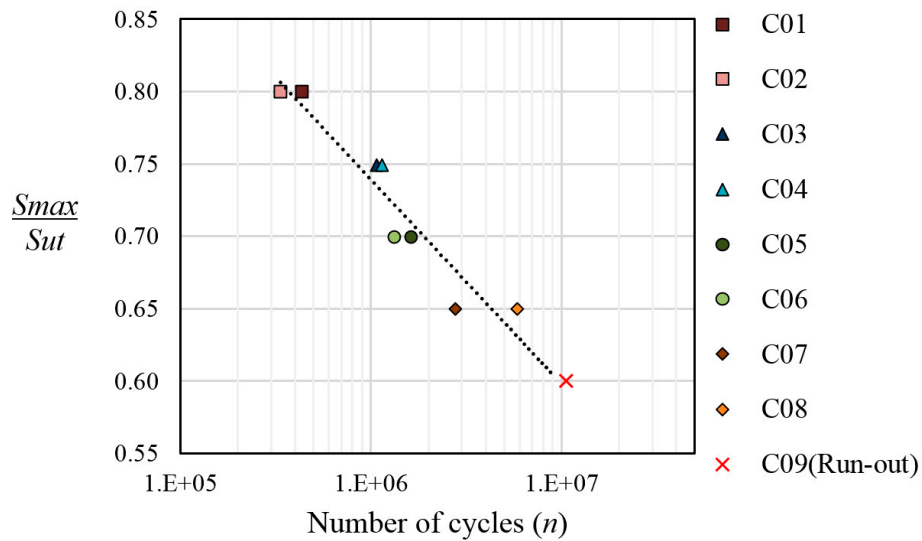
Figure 5. Gassner curve in semi-log graphic, for the coupons cycled with the FALSTAFF load sequence at different levels of maximum peak load.

The classical stress-life curve (S-N) which is used to characterize the fatigue properties at CALs, can be used in a modified version for VALs to present life results, by plotting the maximum peak stress (S_{max}) versus the number of cycles until failure (N). The resultant curve is known as Gassner curve [3]. Figure 5 shows the Gassner curve for the coupons cycled at different levels of maximum peak load. The trend line shown in the graphic has been adjusted using the failure data of the coupons C01 to C08. The coupon C09 loaded at $S_{max} = 0.6S_{ut}$ survives 10.5×10^6 cycles and its failure cycle is unknown.

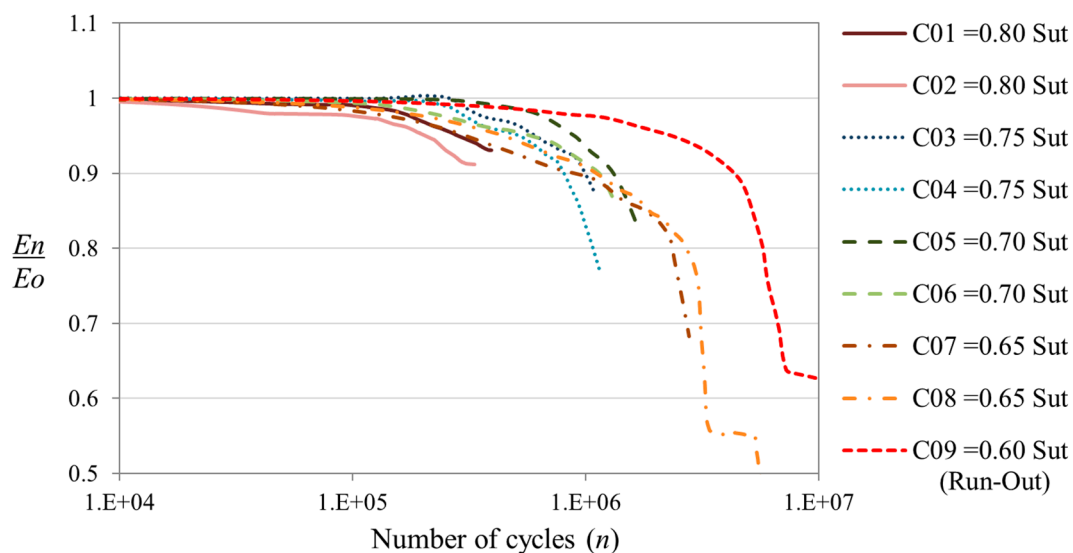
Figure 6. Stiffness degradation in semi-log graphic, for the coupons cycled with the FALSTAFF load sequence at different levels of maximum peak load.

The stiffness degradation of the coupons has been measured during the fatigue cycles. The value of the stiffness has been calculated taking into account the displacement of the test machine and the applied load. The stiffness measurements have been treated in order to obtain normalized values and to quantify the stiffness degradation in terms of percentage of the initial stiffness. Figure 6 shows the degradation of the stiffness due to the accumulated damage of the coupon. The plot shows that the coupons cycled with VALs of higher severity presents a faster degradation of the stiffness, because higher loads produce more damage in the composite material. This behavior was expected and is in accordance with the results obtained when CALs are applied [18] and confirms that the stiffness degradation can be used as a metric to determine the damage state due to fatigue loads.

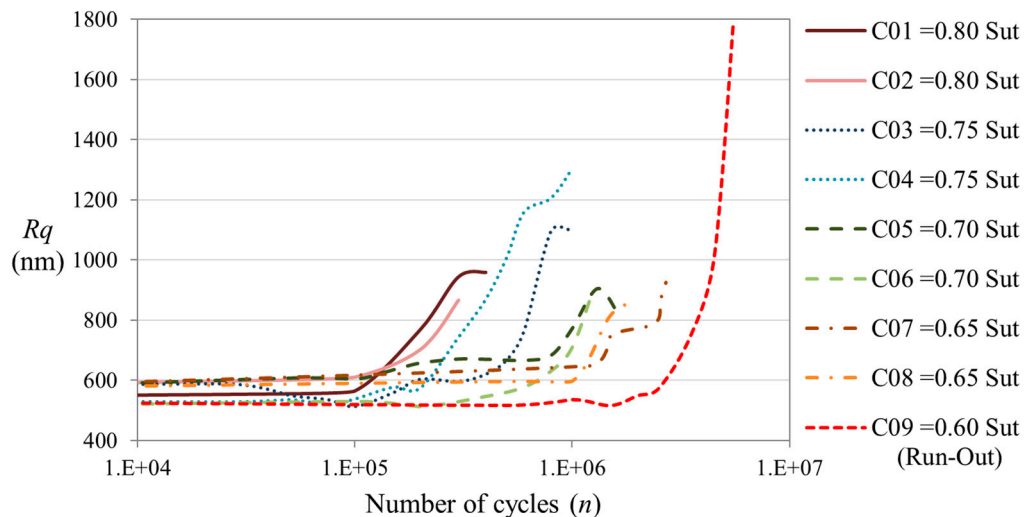
Figure 7. Evolution of the surface roughness magnitude quantified by the parameter R_q during the VALs.

Figure 7 shows the evolution of the surface roughness magnitude due to damage accumulation in the material. The magnitude of the roughness has been quantified by the parameter Rq , Equation (1). The graphic shows that the magnitude of the roughness increases due to the accumulation of damage on the material. The rate of increment is highly dependent on the applied load level. The roughness grows faster when the applied load spectra is more severe. This is because a faster growing of the damage is produced in the material when is cycled at higher loads. This behavior is similar to the results of stiffness degradation.

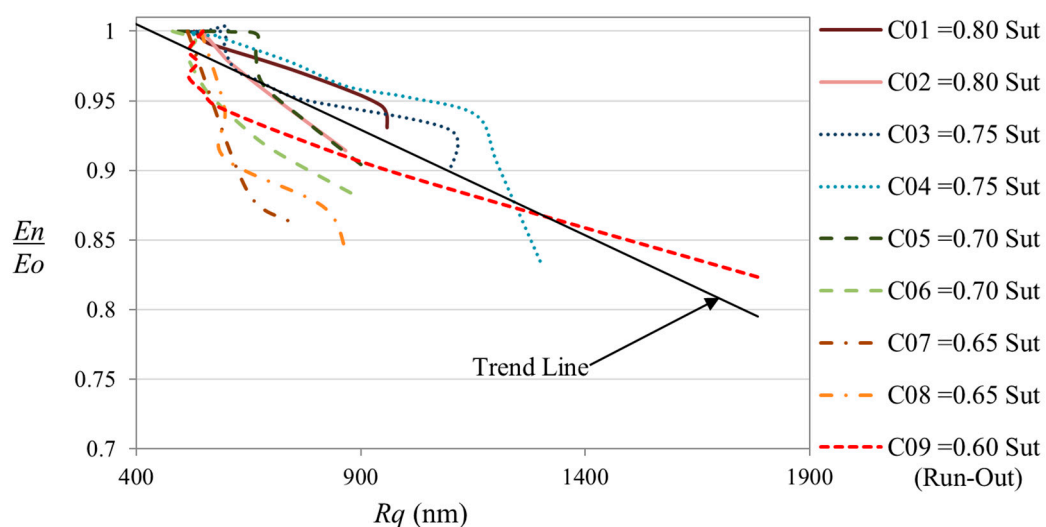
Figure 8. Correlation between stiffness degradation and surface roughness magnitude (R_q) at VALs. The trend line is obtained combining the roughness and stiffness data of all the coupons.

Figure 8 shows the relation between the structural damage measured by the roughness magnitude R_q and the damage measured by the stiffness degradation. The graphic shows that the surface roughness tends to increase with the degradation of the stiffness. A linear Pearson correlation between both parameters has been determined with a magnitude of 0.75. We consider this correlation as good for the case of evaluate fatigue damage by non-destructive methods. This is because the fatigue is a stochastic phenomenon. The scattering in the life results for the evaluated material when the same geometry and the same level of load is applied, could be around one decade in the logarithmic scale [6]. This scattering is due to manufacturing process of the CFRP that could produce different type of imperfections in each coupon.

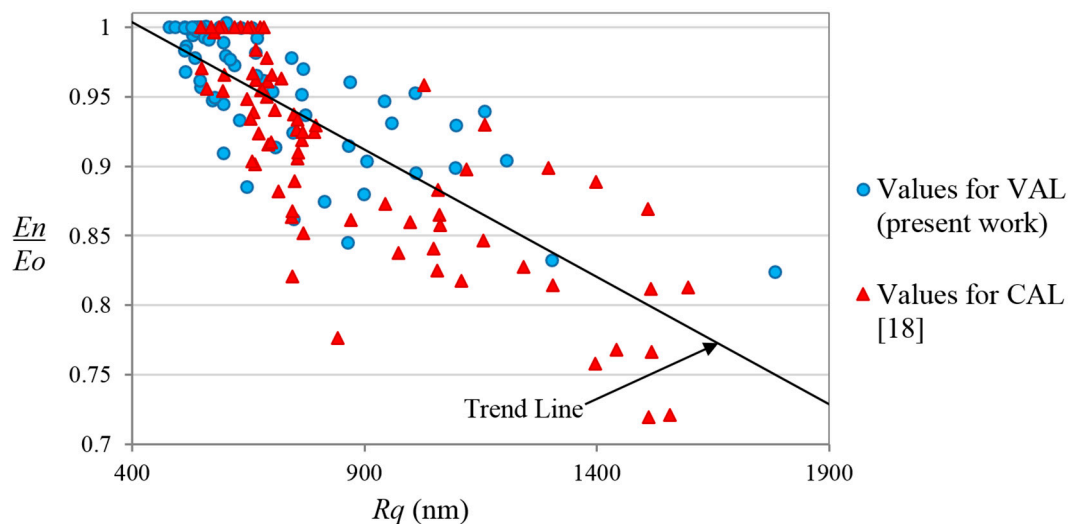
Figure 9. Comparison between the data obtained for VAL in the present work, and the data obtained for CAL in a previous study [18]. The trend line is obtained for the combination of both studies.

The results of the correlation between the stiffness degradation and the increment of the roughness magnitude, obtained in the present work with realistic in-service loads (VAL), have been compared with results reported in previous studies obtained with the same methodology for CAL [18]. Figure 9 shows both data superimposed. The results for both studies show similar tendencies and similar statistics and scattering. Taking into account both data (CAL and VAL), the Pearson correlation coefficient between stiffness degradation and roughness magnitude is 0.80. We can conclude from this comparison that the results obtained by the present methodology are independent of the load type applied, and can be used for applications where the in-service loads are known and controlled (such as pressure vessels) and for applications where the loads are of random or variable nature (wings, automotive components, *etc.*).
